DEPARTMENT OF TRANSPORTATION

Contract #: 04-0120F4Cty: SF/ALA Rte: 80 PM: 13.2/13.9File #: 69.28**WELDING INSPECTION REPORT****Resident Engineer:**Pursell, Gary**Address:** 333 Burma Road**City:** Oakland, CA 94607**Report No:** WIR-001457**Date Inspected:** 05-Feb-2008**Project Name:** SAS Superstructure**OSM Arrival Time:** 700**Prime Contractor:** American Bridge/Fluor Enterprises, a JV**OSM Departure Time:** 1600**Contractor:** Zhenhua Port Machinery Company, Ltd (ZPMC), Changxing Island **Location:** Shanghai, China**CWI Name:** Sha Zhi**CWI Present:** Yes No**Inspected CWI report:** Yes No N/A**Rod Oven in Use:** Yes No N/A**Electrode to specification:** Yes No N/A**Weld Procedures Followed:** Yes No N/A**Qualified Welders:** Yes No N/A**Verified Joint Fit-up:** Yes No N/A**Approved Drawings:** Yes No N/A**Approved WPS:** Yes No N/A**Delayed / Cancelled:** Yes No N/A**Bridge No:** 34-0006**Component:** OBG**Summary of Items Observed:**

Orthotropic Box Girder (OBG)

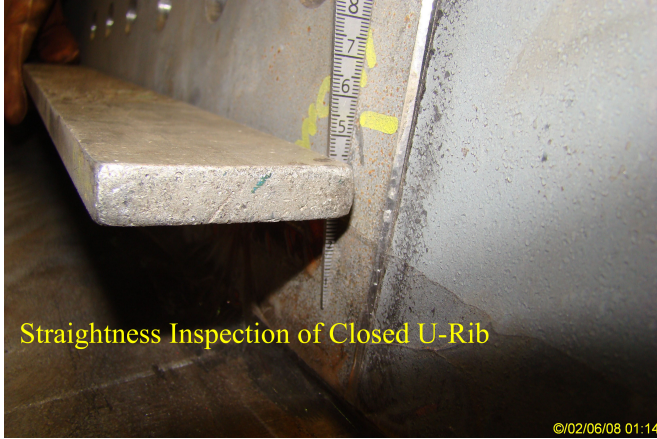
In Bay 1 the flatness of the bolted flange sections at both ends and sides of the closed u-ribs on Deck Plate DP058 PL14B were checked using a 1000 millimeter straight edge and a gap rule. Readings were taken just above the tack welded PJP weld, at the middle line of bolt holes and above the top row of bolt holes at the upper flange edge. A simple spreadsheet was made out containing the data and turned over to the Structural Material Representative (SMR) Mr. Adi Velasco. QA Inspector Paul Dawson assisted in the collecting of this data.
